MONITOR TAP SOUCAN

New, more robust, silicone-free design.

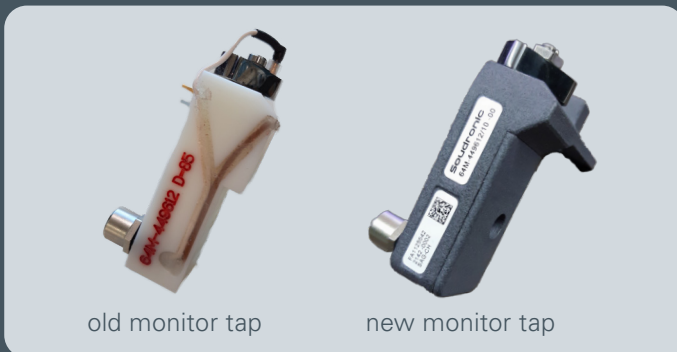
The monitor tap has been redesigned comprehensively. Previously, the cables were inserted in cable guiding grooves, which were sealed with silicone.

old monitor tap

new monitor tap

In addition, the cable contact point was very exposed and susceptible to damage from crashes and mishandling. Now all components are safely accommodated in a robust housing made with state-of-the-art 3d printing technology. The use of silicone, which can cause problems in the filled product, has been eliminated.

- Less prone to damage due to protected cable routing
- Silicone-free
- Wear part replacement with conventional tools

- All SOUCAN machines
- The carbide contact segment (wear part) remains unchanged

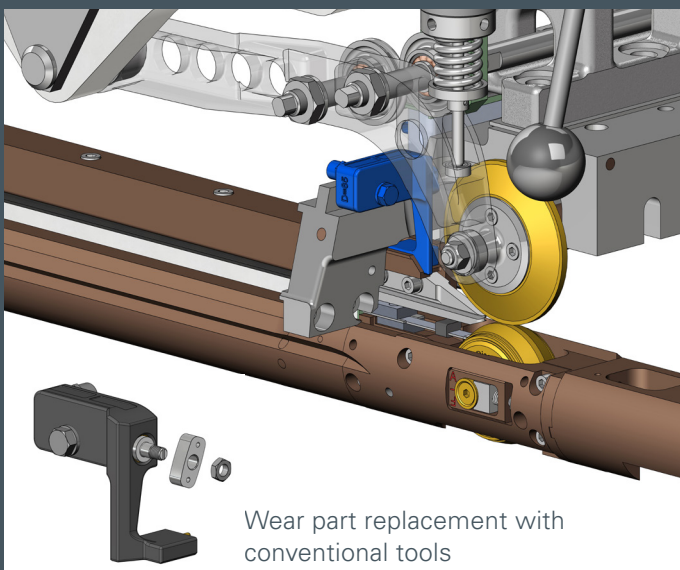
The contact segment remains unchanged and will be used in all SOUCAN welders. It can be easily turned so that both sides can be used. Replacement is carried out by using a conventional screwdriver and open-end wrench.

Wear part replacement with conventional tools
